NASA (TECHNICAL NOTE)

(NASA TN D-3512)

(HYPERVELOCITY IMPACTS INTO STAINLESS-STEEL TUBES ARMORED WITH REINFORCED BERYLLIUM)

**HYPERVELOCITY IMPACTS INTO STAINLESS-STEEL TUBES
ARMORED WITH REINFORCED BERYLLIUM**

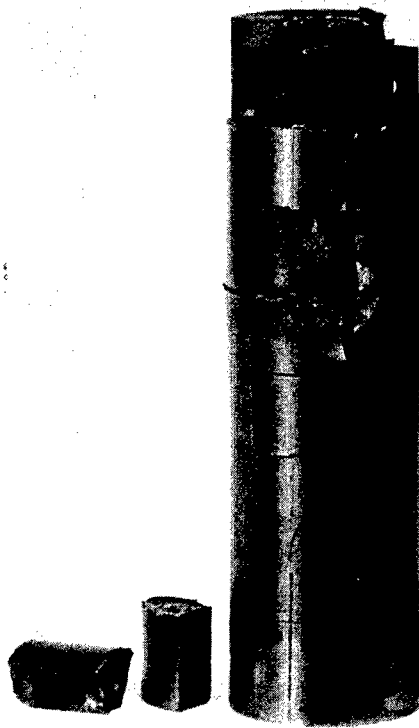
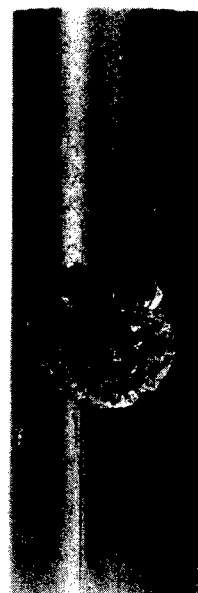
Unreinforced (target 5)

Compartments (target 1)

Concentric shells of mesh
(target 2)

Uniformly dispersed fibers
(target 3)

Figure 8. - Comparison of impact damage on tubes armored with unreinforced and reinforced beryllium. Nominal impact conditions: projectile, 3/32-inch-diameter Pyrex sphere; impact velocity, 24 000 feet per second; target temperature, 1300° F.

Comparisons. - Figure 8 shows a comparison of the unreinforced-beryllium-armored tube from reference 4 and the reinforced-beryllium-armored tubes tested in this investigation. As indicated previously, all targets were comparable in dimen-

A front-surface spalled area and radial cracks appeared on the target shown in figure 7. The compartmented design, however, had the most extensive armor loss and cracking damage in comparison with the unreinforced armor. The mesh and fiber reinforcements did not significantly reduce or limit the external cracking damage. Each of the four armor configurations prevented the 3/32-inch-diameter Pyrex sphere from perforating the internal liner, and all the targets were dimpled on the inner surface of the tube under the point of impact.

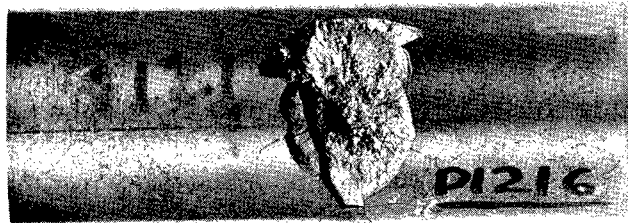
First impact

View of both impacts

Second impact

Figure 9. - Fiber-reinforced beryllium armored tube after two impacts. Test conditions (each impact): 3/32-inch Pyrex sphere; nominal impact velocity, 24 000 feet per second; target temperature, 1300 F.

Double impact. - A fiber-reinforced target was impacted twice to determine if repeated impacts would result in removal of large segments of the armor cracked by the first impact. On the particular target tested, the second impact was made approximately 90° from the first impact in the same plane. Figure 9 shows both impacts and the condition of the armor between the craters. Large segments of the armor were not lost, and the increase in cracking damage was not appreciable. The cracked area around the second crater was slightly larger than that around the first crater, as can be seen from a

comparison with figure 8. Neither of the impacts, however, perforated the liner tube, and only internal dimples were visible on the inside surface of the tube.
